EVALUATION OF A CYLINDRICAL WEDGE-WIRE SCREEN SYSTEM AT BEAL LAKE, ARIZONA, 2005

PREPARED FOR:

**Bureau of Reclamation
P.O. Box 81470
Boulder City, NV 89006**

**Normandeau Associates, Inc.
Pacific Northwest Office, Stevenson, Washington
Corporate Headquarters, Bedford, New Hampshire**

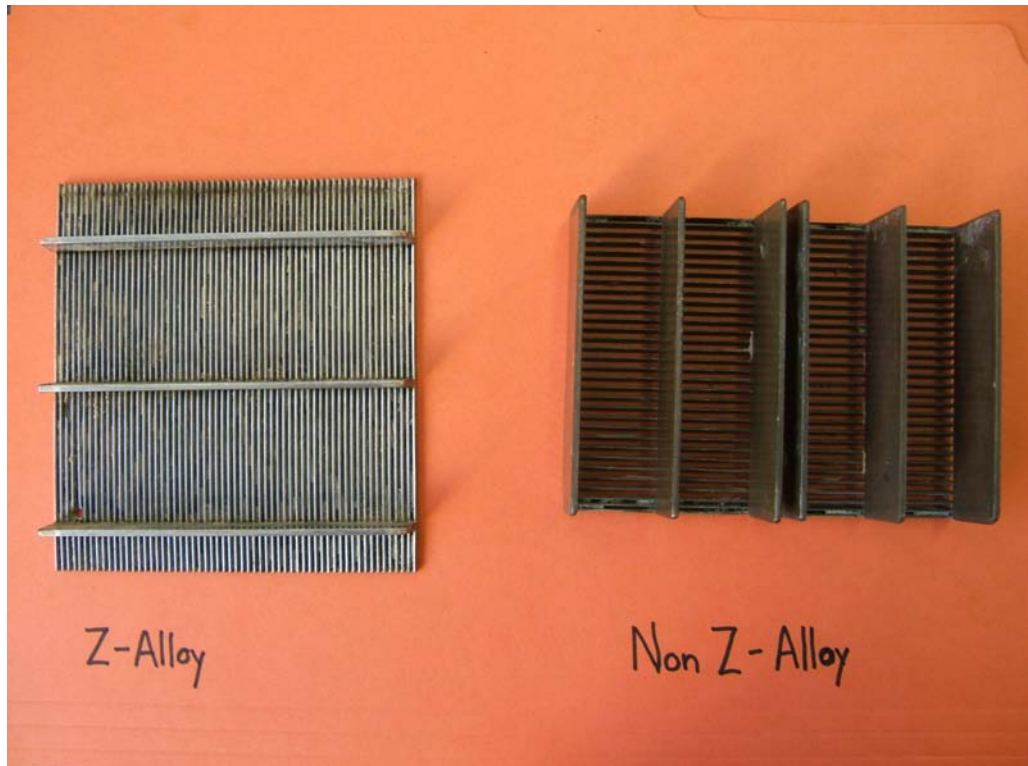
Based on side by side comparisons, the Z-Alloy screen sample appeared to be more heavily fouled than the non-Z-Alloy samples. The entire surface of the Z-Alloy sample (both sides) was covered with a microbial mat that filled approximately 90% of the interstitial spaces between the screen ribs. The microbial mat on the screen consisted of a mixture of various bacterial colonies and their extracellular metabolites, decaying organic matter, and mineral particles (*i.e.*, silt and clay). A variety of small invertebrates such as nematodes, rotifers, oligochaetes and ostracods were found to be living within the microbial mat that covered the screen sample. The outer smooth surface of the screen sample contained a large number of diatoms. Animal tubes, inhabited by several species of chironomids were also numerous on the Z-Alloy screen sample and, in some areas, completely covered the panel face. The underside of the sample also had a relatively small colony of the ectoproct bryozoan (*Plumatella casmiana*). The colony appeared to be in a dormant state, but there were numerous statoblasts (*i.e.*, reproductive structures) present.

Approximately 30% of the surface of each non-Z-Alloy sample was covered with a thin layer microbial mat, with the remaining surface area being clear. The outer surfaces of the samples were almost entirely clear of fouling material with a few animal tubes (particularly Chironomids) on the inner side of the screen (the side containing the cross-supports).

None of the organisms were observed to be securely cemented to either the Z-Alloy or non-Z-Alloy screen samples as is often observed with barnacles and some insects. The bryozoans, and animal tubes were lightly attached to the surface of the screen samples although they seemed to be relatively easily removed by light scraping or brushing. The microbial mats were also easily removed by light surface agitation.

Figure 7. Z-Alloy and non-Z-Alloy samples installed side by side near the existing screened pipes.

- *Continued evaluation of Z-Alloy* — We recommend that further evaluation of the effectiveness of Z-Alloy as an anti-biofouling agent should be conducted in Beal Lake using a large number of screen samples. These evaluations should also be extended into waters closer to the main channel of the Colorado River where water conditions are different than those found in Beal Lake.

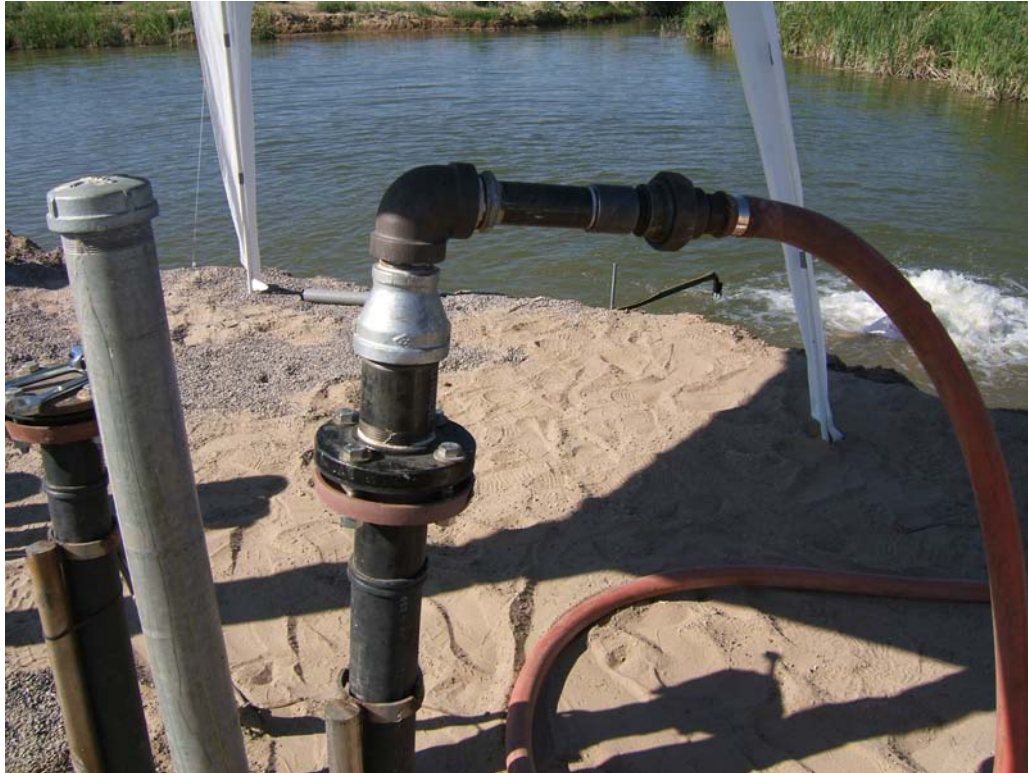
An evaluation of the air backwash system was conducted on 12 July, 2005. A Bureau of Reclamation crew from Yuma, Arizona operated the backwash system. Each screen was backwashed with a maximum of 80 psi; higher air pressure was not tested due to uncertainty regarding the limits of the screen system. As the air backwash system was operated, a large plume of sediment was observed dissipating off the screens (Figure 12). However, physical inspection of the screens while the backwash system was in operation revealed that a majority of the air from the airburst system was

Figure 8. Air compressor hose attached to screen backwash system.

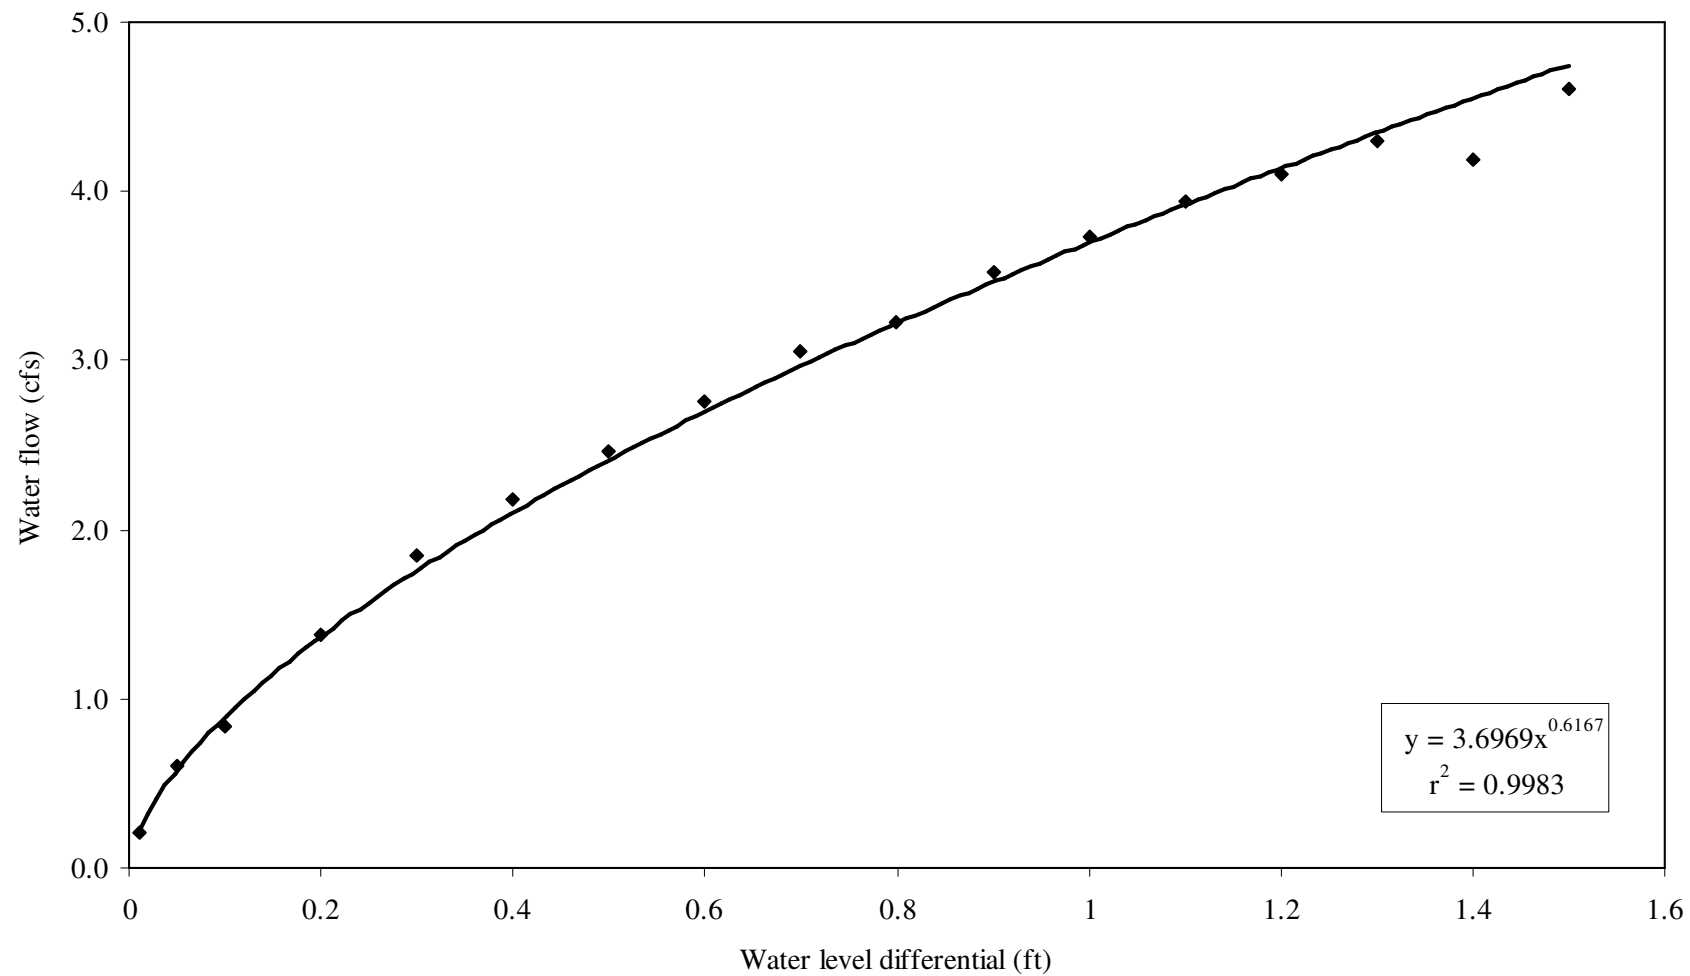
The flow measurements through the screen system indicate that each pipe is capable of delivering approximately 5 cfs or 9.9 acre ft/day of water at a 2 ft head differential; the combined capacity of the 3 pipes currently screened is approximately 29.7 acre ft/day. This combined value is more than 4 times the 7 acre ft/day evapotranspiration rate estimated to occur from Beal Lake during the summer (BOR 2003).

Because flow through the pipe was non-linear, power regression was used to estimate pipe flow as a function of head differential (Figure 11). The best-fit equation yielded an $r^2 = 0.998$, and was calculated as:

Figure 11. Water flow through the screened pipe as a function of head differential between Topock Marsh and Beal Lake.

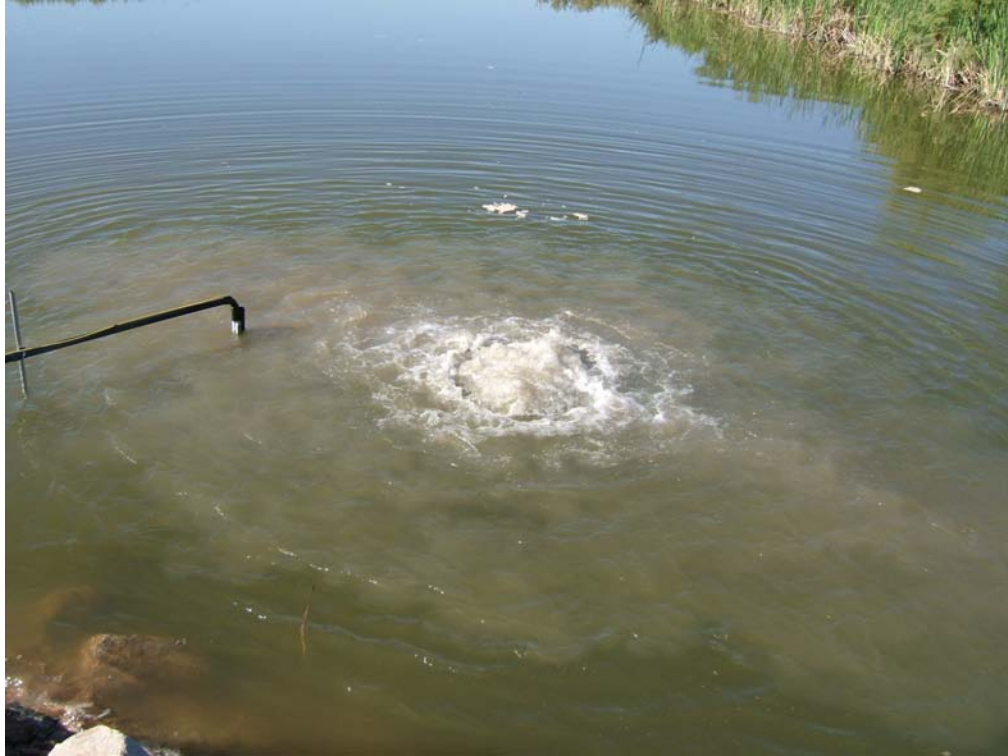
escaping through the upper portion of the screen, thereby effectively cleaning only the upper third of the screen. The limited ability of the air backwash system to clean the entire screen was evident when the screens were dewatered following the procedure and sediment was observed to be still covering a majority of the screen surface. Sediment was observed to be especially thick on the lower portions of the screens. As an alternative method of cleaning the screen, a nylon utility brush was used to scrub the external surface of the entire screen surface. This proved to be a relatively quick and effective method for removing surface sediment and other material from the surface of the screens.

Figure 12. Sediment plume originating from submerged screens during the air backwater test.

- *Screen maintenance* — Use of the air backwash system was found to inadequately clean the entire surface of the screens. In contrast, physically brushing the screens was found to be an effective cleaning method, and would require a minimal investment in materials and personnel time. We recommend brushing of the screens once a month during May, June, July, and August to ensue optimum system operation when evaporative losses are highest. Bimonthly brushing of the screens is recommended during other months when evaporative losses from Beal Lake are lower. Artificially increasing the amount of water flow through the pipes by augmenting water levels using the irrigation pump is recommended at Beal Lake annually to reduce in-pipe sediment deposits.

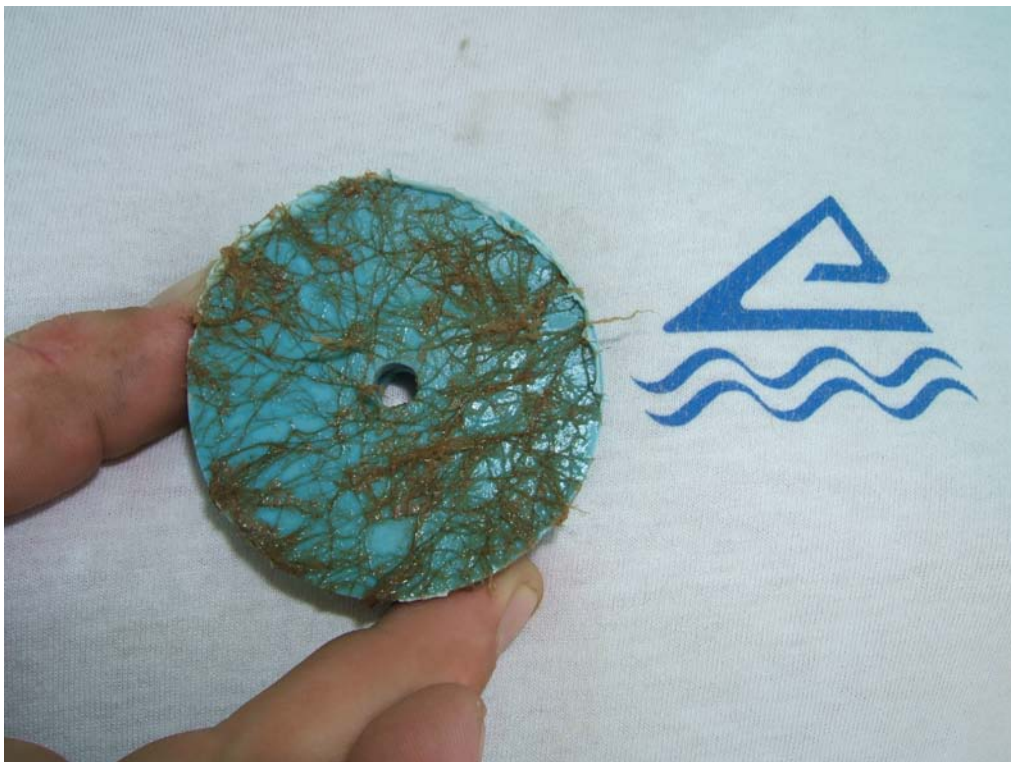
Figure 13. Colonial hydrozoa from the genus *Cordylophora* attached to the inside of a section of PVC pipe removed during the installation of the flow meter.

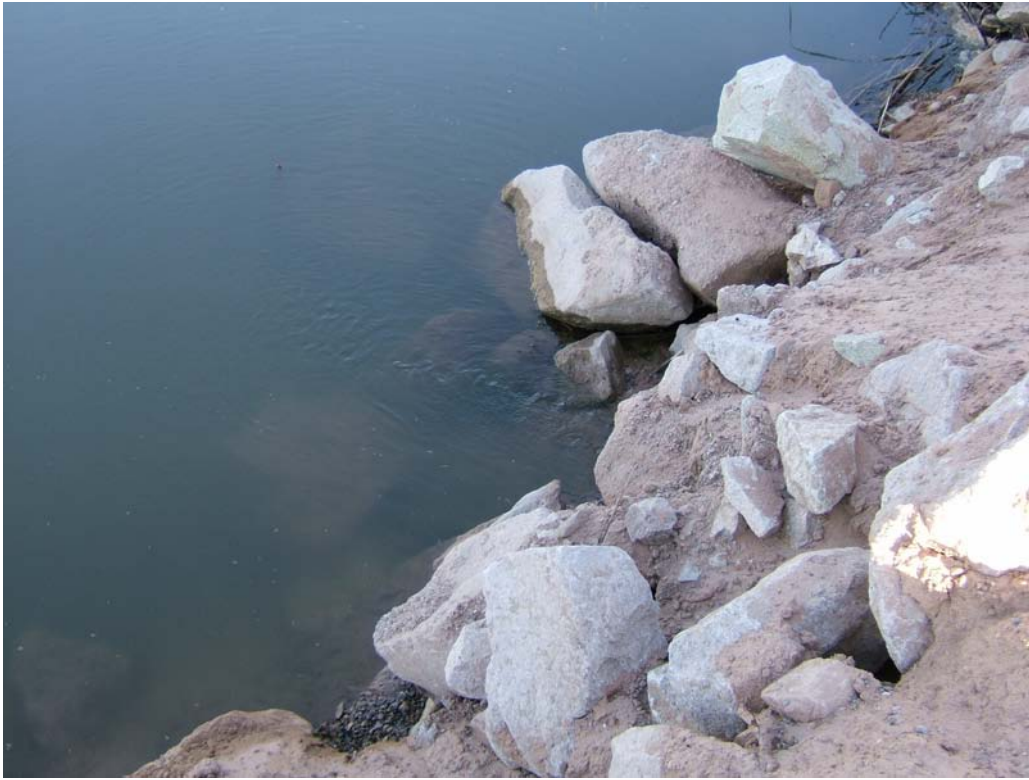
It was observed when the water level in the Topock embayment was drawn down to create a head differential between the embayments, there was a noticeable volume of water permeating through the rock structure (Figure 14). This was particularly evident along western side of the structure immediately adjacent to the flow through pipes. While the level of permeation was likely influenced by increased pressure from adjusting water levels on either side of the rock structure, substantial infiltration of flow through rock structure could have a negative effect on the biological exclusion ability of the screen system.

Figure 14. Water permeating through the rock structure.

- *Evaluation of water flow through the rock structure* — Quantifying the volume of flow passing through the rock structure was not conducted during this evaluation. During testing, we observed water permeating through the rock structure. Information regarding the volume of flow passing through the existing rock structure at Beal Lake may prove to be valuable when designing and installing screen systems at other locations. In addition, the amount of flow permeating through the rock structure should be evaluated to assess the integrity of the rock structure in excluding all life stages of nonnative fishes.

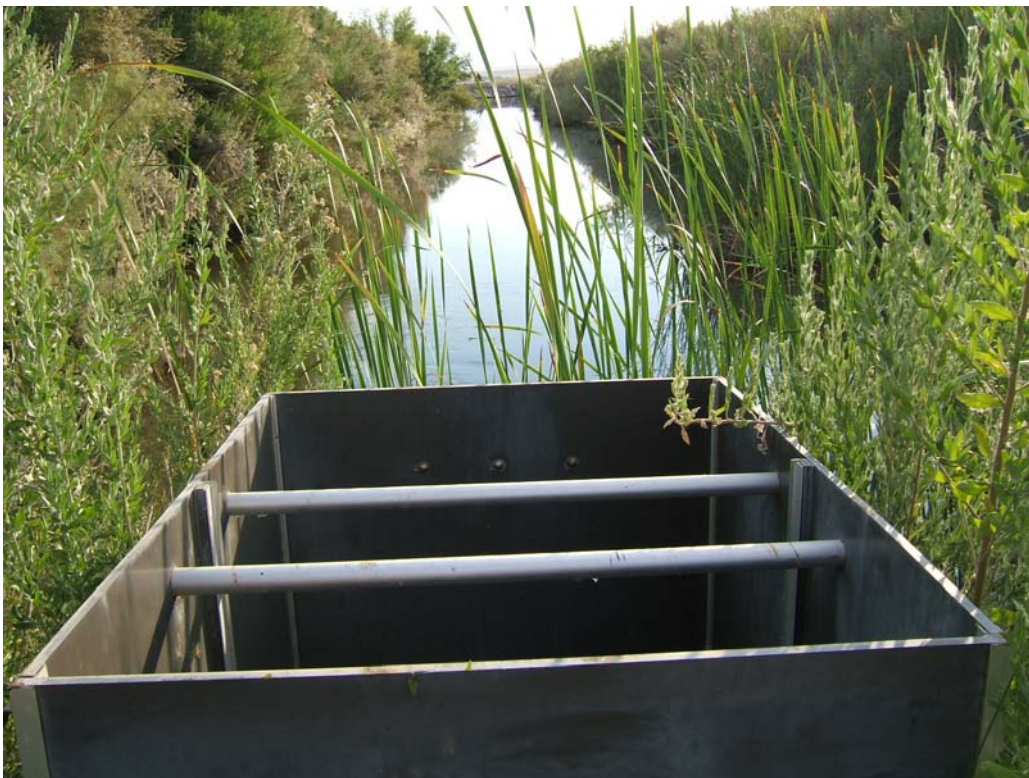
The flow control structure that is located in the canal connecting the rock structure to Beal Lake consists of a single 24-inch box-culvert buried within an earthen dam (Figure 15). During our evaluation of the screen system, we noticed that a considerable amount of water was moving through this structure. While this flow was not measured, based on the size of the structure, we estimated the

hydraulic capacity of the screen system is nearly twice that of the box-culvert. Consequently, the rate of water being delivered into Beal Lake may be limited.

Figure 15. Box-culvert located in the channel connecting the rock structure to Beal Lake.

limiting water into Beal Lake. It is recommended that this downstream flow control structure be evaluated, and if necessary, modified to increase the hydraulic capacity or removed entirely.
